INVESTIGATION OF CHANNEL SEAL
BLOW-BY PHENOMENON

JUNE 1966

SYSTEMS ENGINEERING GROUP
RESEARCH AND TECHNOLOGY DIVISION
AIR FORCE SYSTEMS COMMAND
WRIGHT-PATTERSON AIR FORCE BASE, OHIO

3. REPORT TITLE Investigation of Channel Seal Blow-by Phenomenon		2b. GROUP
4. DESCRIPTIVE NOTES (Type of report and inclusive dates) Test Program Final Report

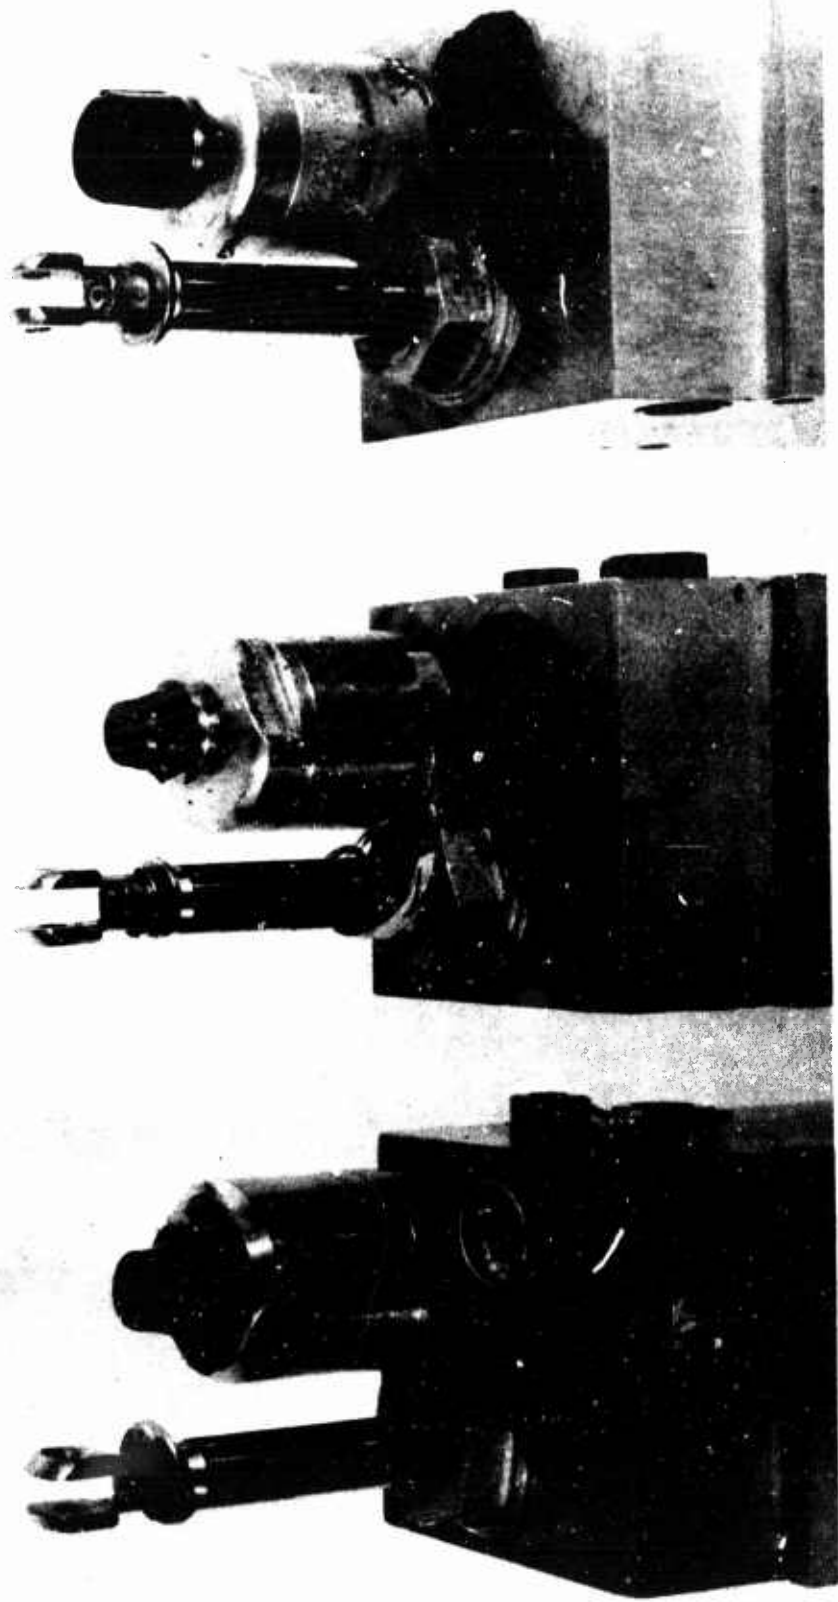
During this test program, it was noted that the test actuator valve metering control rod could be pushed far enough to permit a washer on the rod to enter the valve block a distance of approximately .125 inches. When this occurred, the actuator valve metering slide assumed a position which blocked fluid pressure and the actuator piston could not move unless the rod was retracted to approximately $\frac{1}{4}$ inch from its neutral center position. Investigations revealed that an incorrect size washer was installed on this actuator metering control rod. This washer had a smaller diameter as compared to the MS 15795-211, which is the correct washer to use for this installation. To correct this condition, the valve block which came with the load actuator replaced the test actuator valve block which had the small washer on the metering control rod. Inadvertently, the MS 15795-211 washer on the replaced valve block metering control rod was bent when the electric motor was started with an excessive speed setting during later phases of this test program. It was found that the bent washer would also protrude into valve block causing the actuator piston to assume a locked position. Investigations were made to determine if this metering control rod bottoming could occur in the KC-135 airplane rudder control system. Discussions with Boeing engineering personnel and maintenance personnel assigned to the 17th Bombardment Wing indicate that the washer installed on the metering control rod stops approximately $\frac{1}{4}$ inch from the valve block if the system is properly rigged. However, during the investigation procedures accomplished in regard to the UR Exhibit received from

FIGURE 5 VIEWS OF METERING CONTROL VALVE FACE

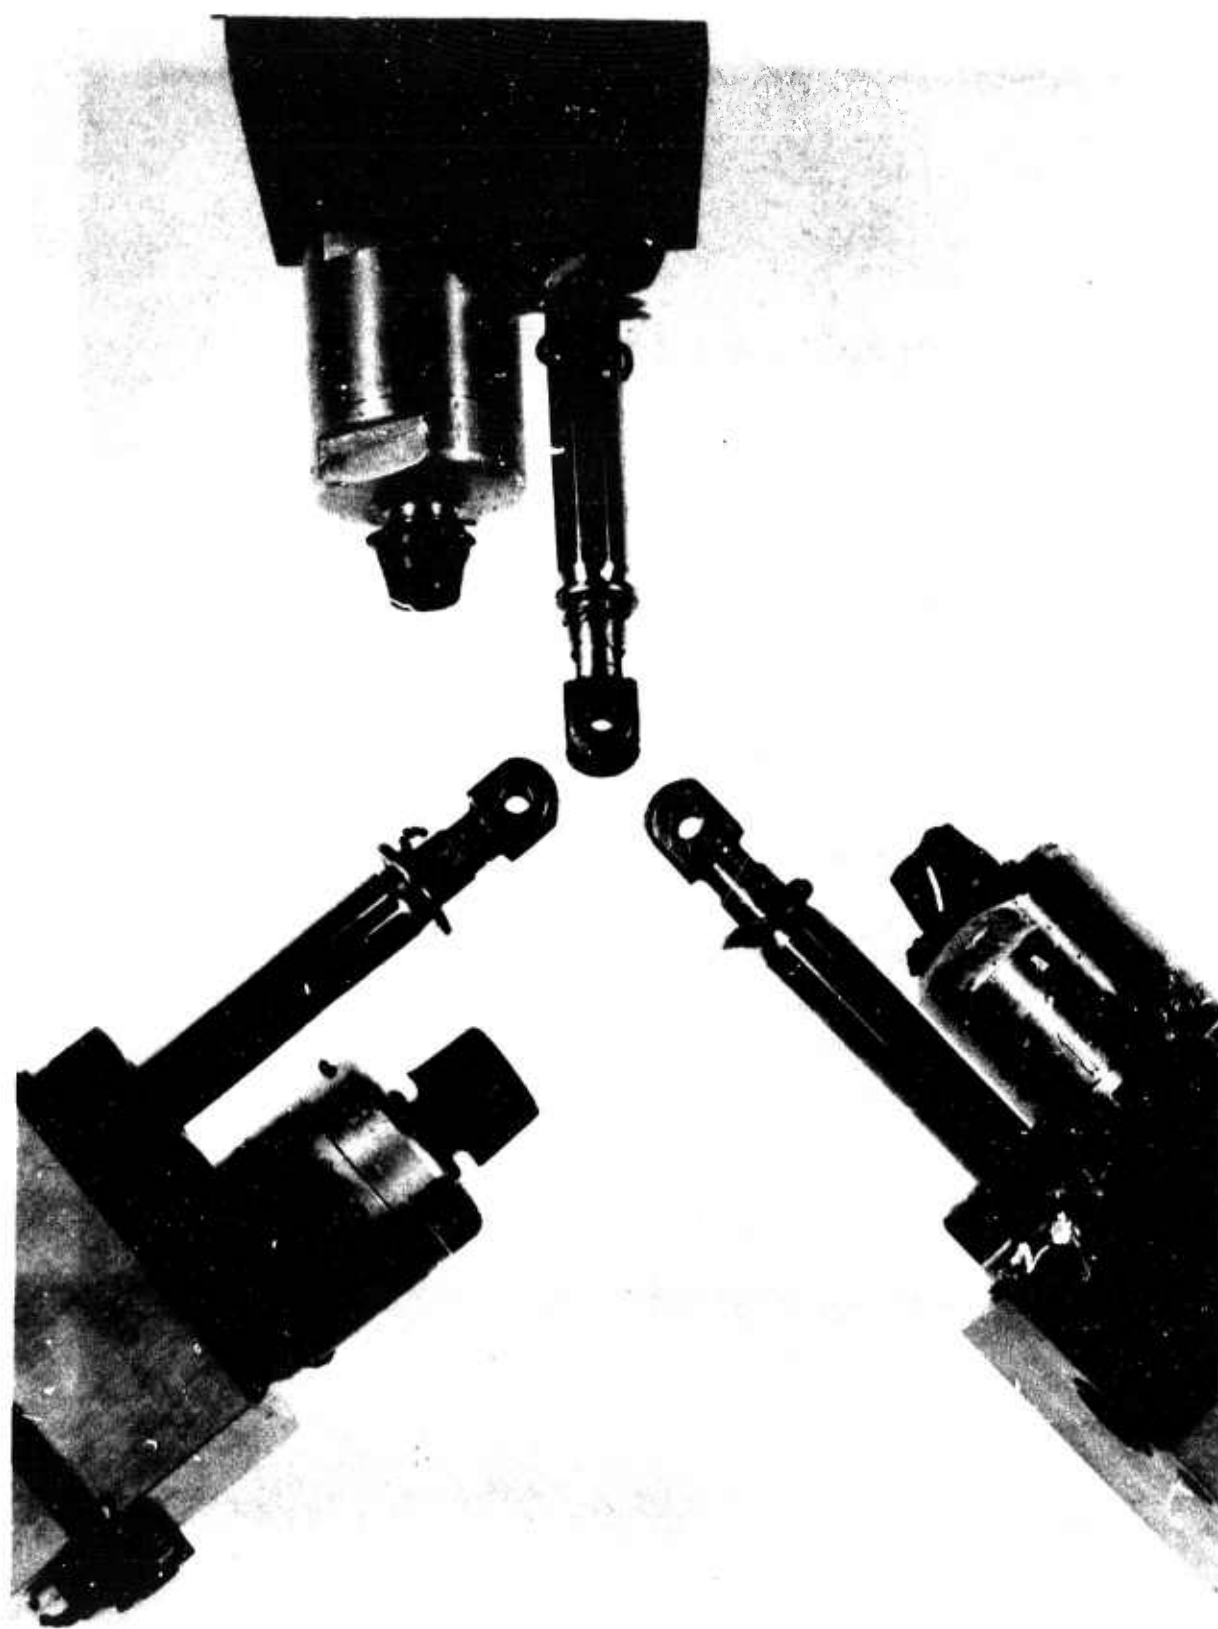
Walker AFB, it was determined that it is difficult to determine if a washer on the metering control rod is bottoming on the valve block. Also, applicable Technical Order procedures do not specify checking procedures to determine if this washer can bottom against the valve block. Photographs are included in Attachment Nr. IX which show the three metering control rods tested during this program. The bent washer and the small washer are shown in this photograph. It is noted that the washer on the opposite end of the metering control rod can also bottom against the valve block. This was demonstrated by loosening the metering control rod nut to only about one thread engagement. To further substantiate that these washers can bottom out in KC-135 airplane rudder actuators, investigations of an operational hazard number 449, BW64-KC-135-4 which occurred at Kinchloe AFB, mentions a bent washer. However, the investigation report OCNCTQ-1 "MIP OC65-7000U1" dated 27 April 1965, states that it appears the washer was bent prior to installing the actuator in the airplane or before the actuator checkout by the investigator.

Over-travel of the metering control rod experienced in this test program could cause erratic rudder responses if this condition prevailed in a KC-135 airplane. Improper washer installations and bent washers installed on the metering control rod could permit over-travel in the airplane provided the rudder control linkages are not properly rigged.

FIGURE 6 WASHER INSTALLATIONS ON METERING CONTROL ROD

It is recommended that the responsible activity at OCAMA take appropriate action to revise applicable Technical Orders to require KC-135 maintenance personnel to check both ends of the rudder metering control rod to determine if the washers bottom on the valve block body.

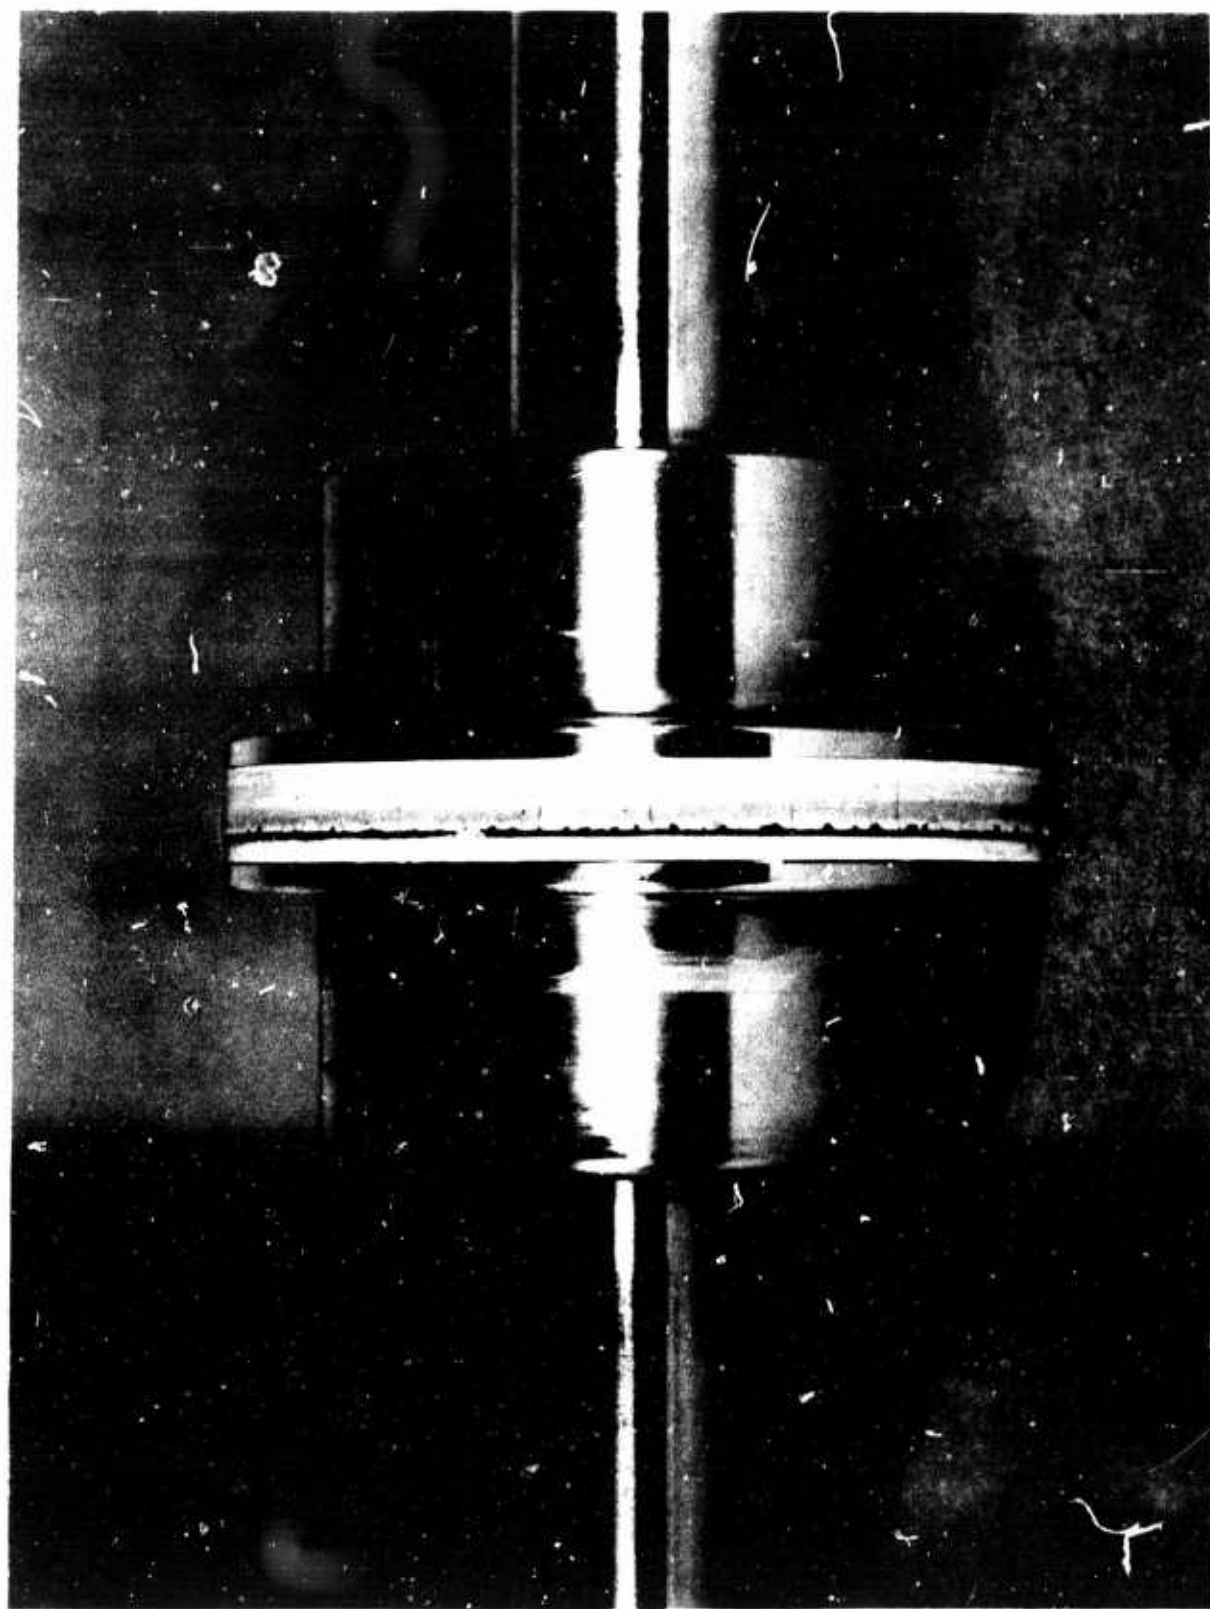
1 April 1966	Movement of the metering rod manually indicated that the actuator valve spool could lock pressure in the piston chamber when the rod travel was at a maximum in one direction. The valve block was replaced on the test actuator. Also, a turcon double delta channel seal was installed in the test cylinder. No blow-by occurrence. Examination of removed valve block indicated that a smaller size washer was installed on the rod permitting the washer to enter the boss on the valve block causing the metering spool to over-travel its design limit.
4 April 1966	No blow-by occurrence detected
5 April 1966	Low temperature test repeated - No blow-by occurrence detected
6 April 1966	No blow-by occurrence detected
7 April 1966	No blow-by occurrence detected
8 April 1966	No blow-by occurrence detected
11 April 1966	Removed test actuator (S/N 151) from stand and installed actuator received from Walker AFB (S/N 332). The actuator performed satisfactorily during these tests. Actuator S/N 332 was removed from the test stand and was disassembled to inspect the channel seal. Fifteen pounds of pull were required to move piston. The channel seal was found to be split circumferentially. Photographs were taken of the damaged channel seal installed on the piston of the actuator.

FIGURE 7 DAMAGED TEFLON CHANNEL SEAL REMOVED FROM
UR EXHIBIT ACTUATOR

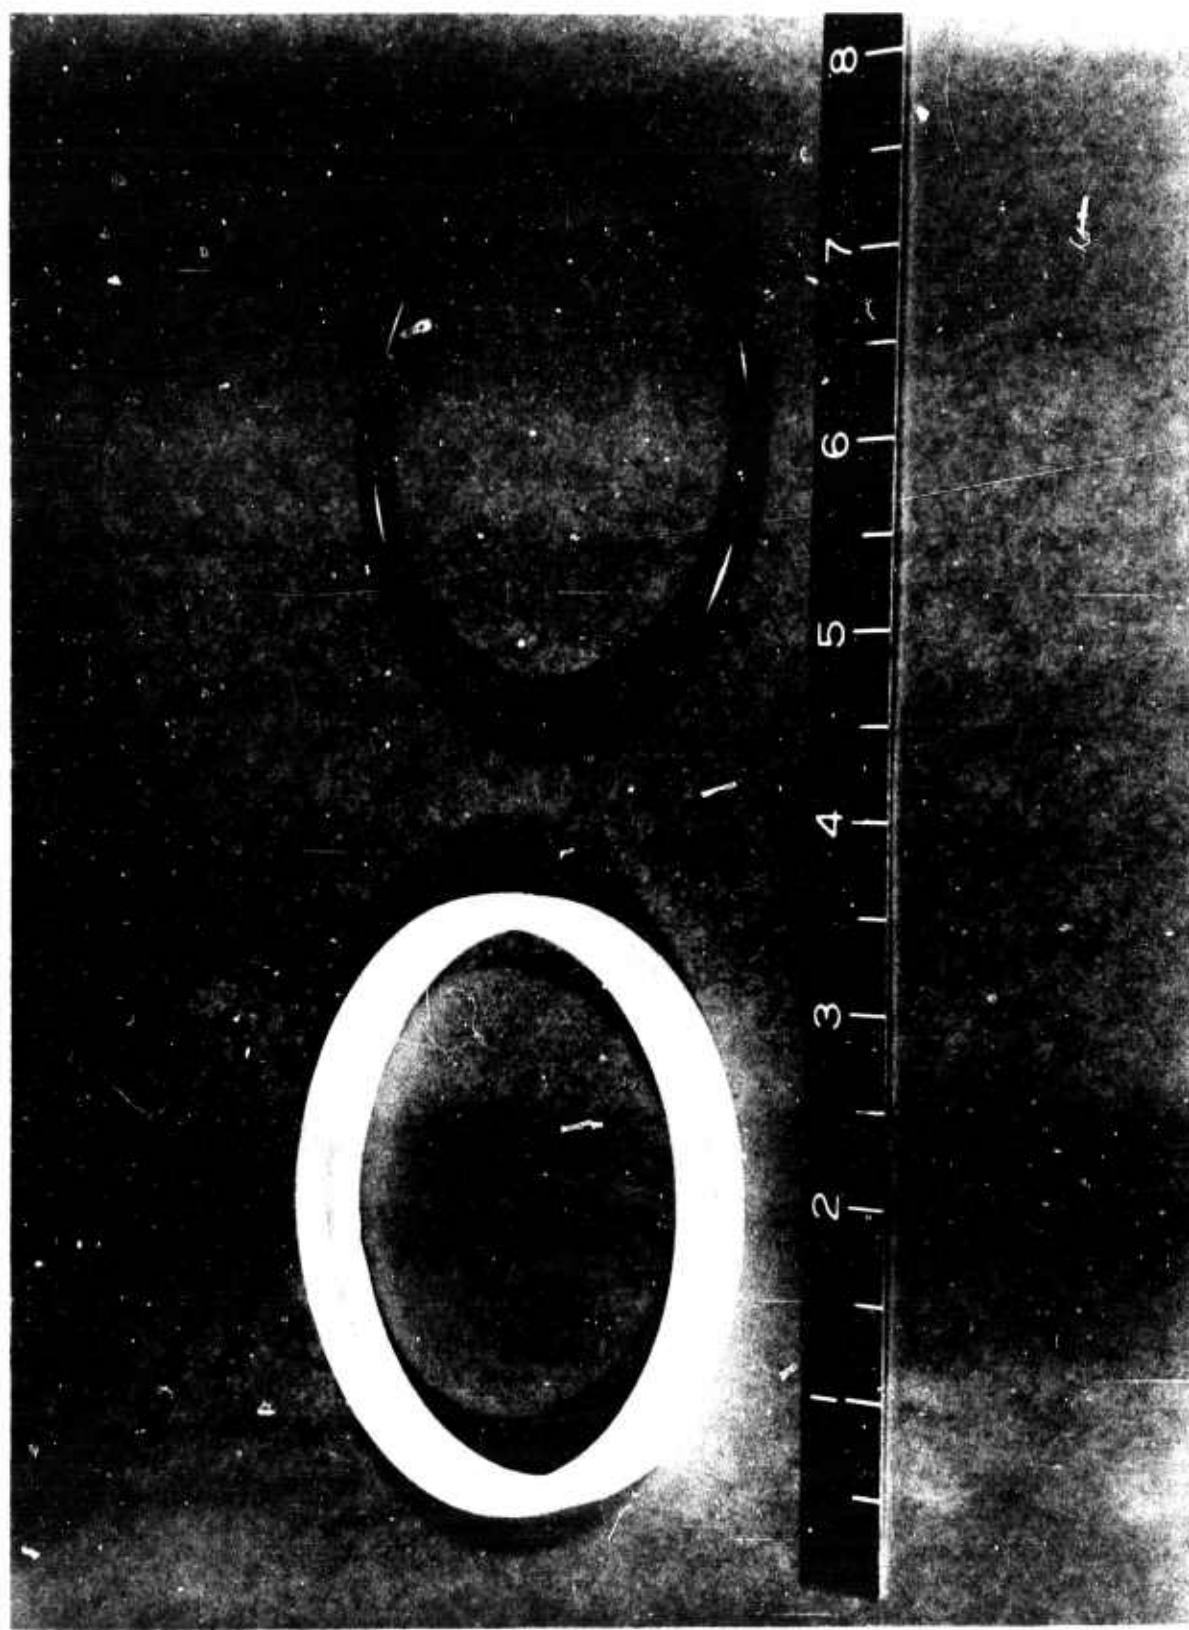
FIGURE 8 VIEW OF THE TEFLON CHANNEL SEAL CONFIGURATION
